Field demonstration of large scale stationary power and CHP fuel cell system

Demonstration of a combined heat and power 2MWe PEM fuel cell generator and integration into an existing chlorine production plant

Deliverable No.	DEMCOPEM-2MW D7.2	
Deliverable Title	D7.2 Report on stack performance and repairs	
Dissemination level	Public	
Written By	Jorg Coolegem (NFCT)	02-01-19
Checked by	Jos Lenssen (NFCT)	14-01-19
Approved by	Ton Pichel (ANIC)	-01-19
Issue date	14-01-2019

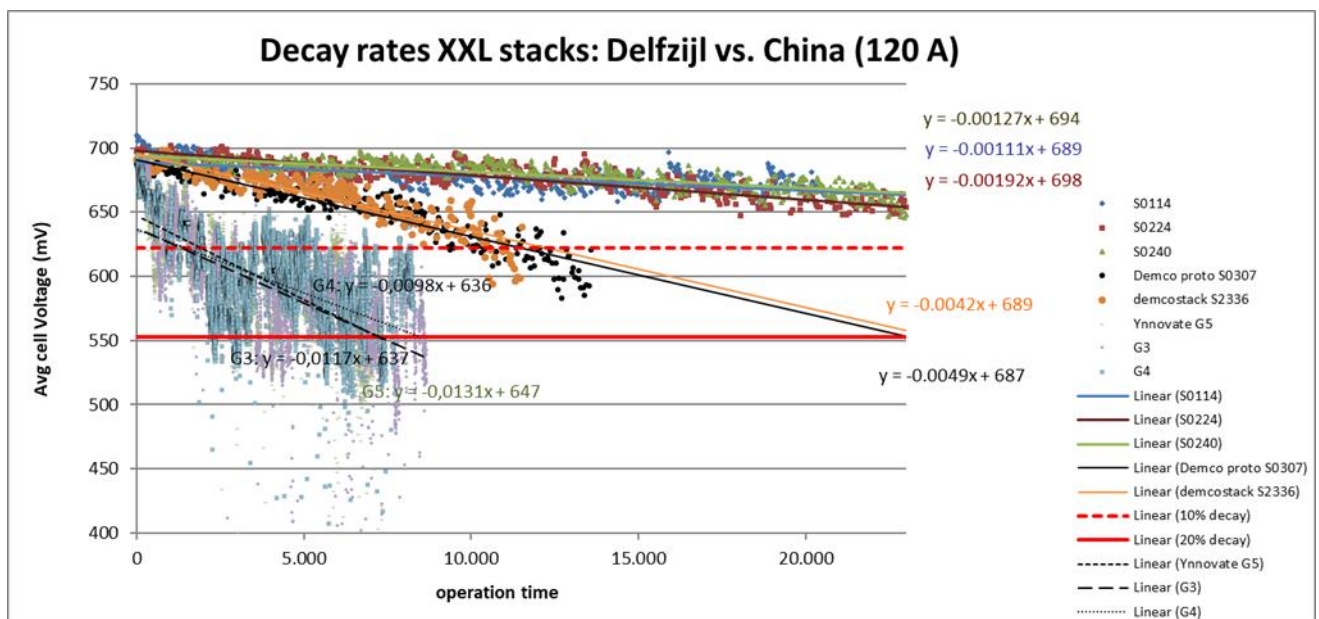
Fig.1 – cell performance in China vs Delfzijl as a function of operating time

In Fig. 1 the performance (avg. cell voltage) is shown as a function of operating time. The Demcopem MEA in stacks S0307 and S2336 shows a slightly higher decay rate in comparison to the latest generation XXL stacks (S0114, S0224, S0240). However, when compared to the average cell voltage of three representative fuel cell groups in Yingkou (G3, 4, 5) a significantly higher decay is observed. Also, the broad scattering of approx. 100 mV shows the excessive reversible decay at the Chinese site, see also D7.1 and the MS 7.1 report where the performance comparison is further detailed and where degraded stacks from China were demonstrated to perform normally again in Delfzijl.

The installation of the additional hydrogen scrubber can be recognized from the interruption in voltage decline around 5000 hrs.

The stack performance of the DEMCOPEM-2MW power plant is found to decrease much faster than in a similar plant in Delfzijl, the Netherlands. The reversible decay is almost 100 fold higher in China, while the irreversible decay is roughly 3 to 10 times higher than Nedstack's XXL stacks in Delfzijl. The reason for this heavily accelerated degradation is due to feed stream contaminations, of both hydrogen and air.

A comprehensive multi-staged action plan was proposed to the plant operator, adding equipment for feed stream treatment to prevent excessive contamination to enter the plant, and as a result prevent deterioration of the stack performance. A limited number of new stacks should be also be included to demonstrate the effectiveness of the proposed improvement plan.
